### GENESIS INCORPORATED TROY MINE

### **REVISED RECLAMATION PLAN**

October 2005 - Revised March 2006 -

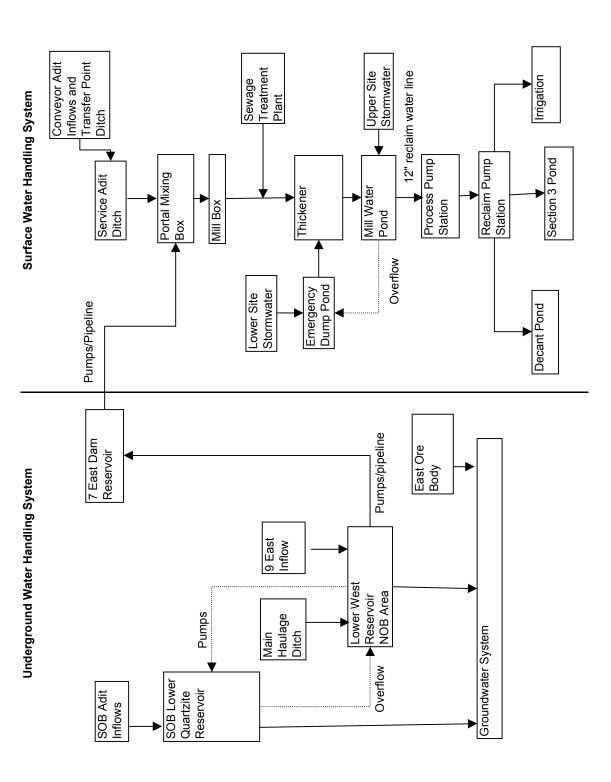
FIGURE 3-2. GENERALIZED FLOW DIAGRAM OF THE TROY MINE WATER HANDLING SYSTEM DURING SHUTDOWN

used to irrigate the tailing for dust control or to assist revegetation. Water at the tailing

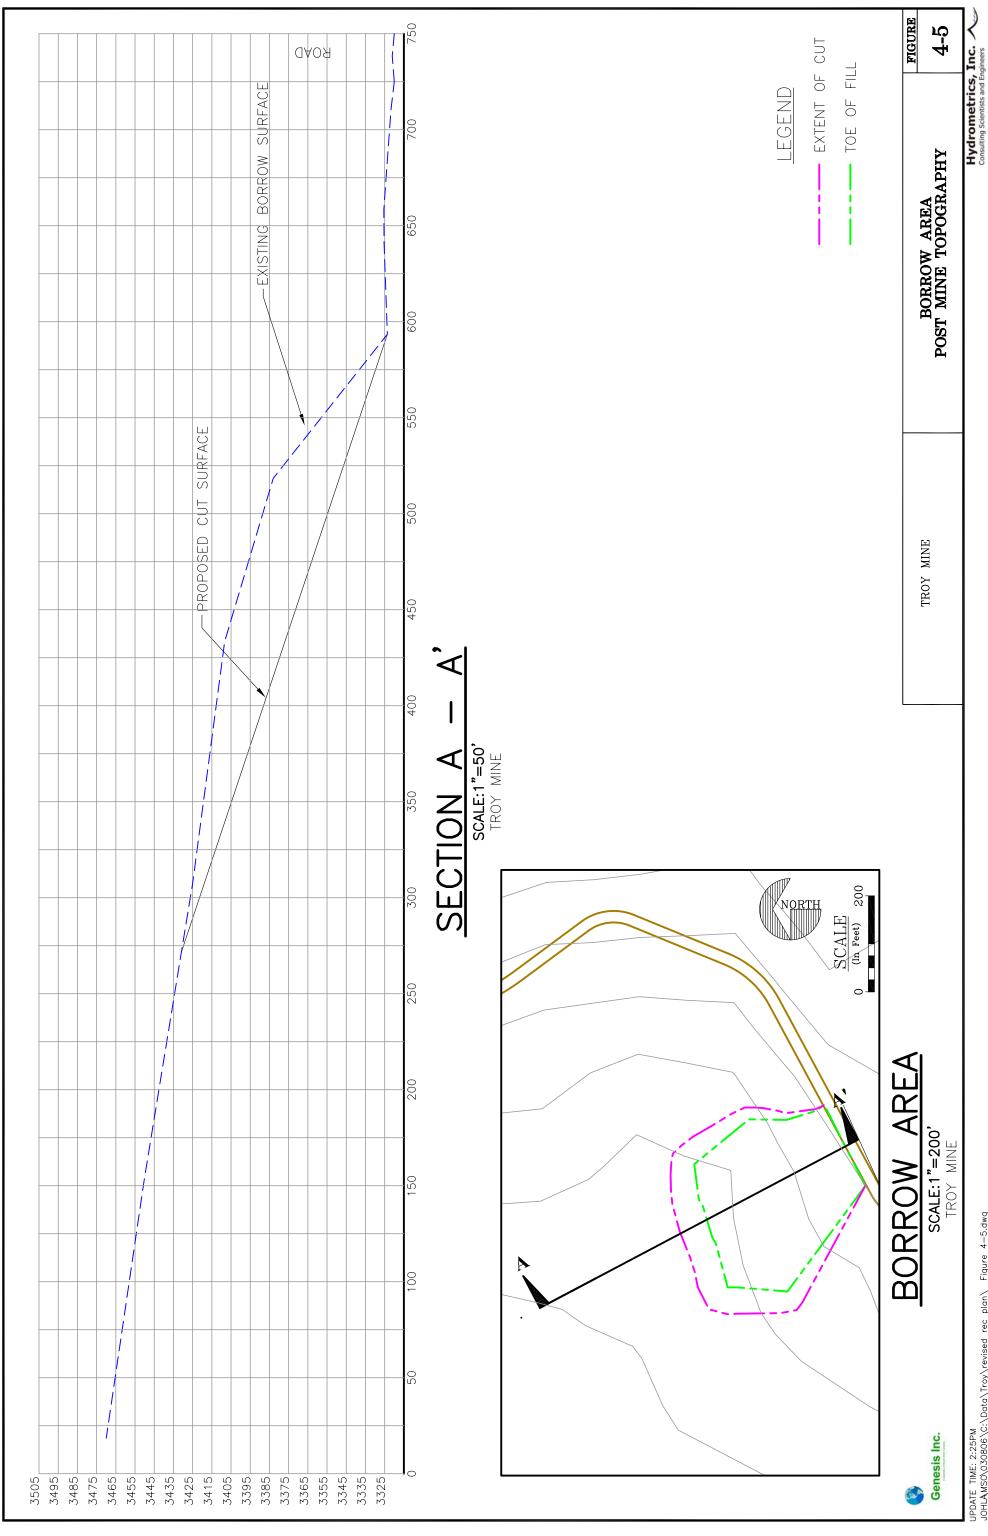
UPDATE TIME: 2:25PM JOHLAMSO\030806\C:\Data\Troy\revised rec plan\ Figure 4-5.dwg

result in final pit slope of 2:1. Figure 4-5 shows a cross section through the existing and

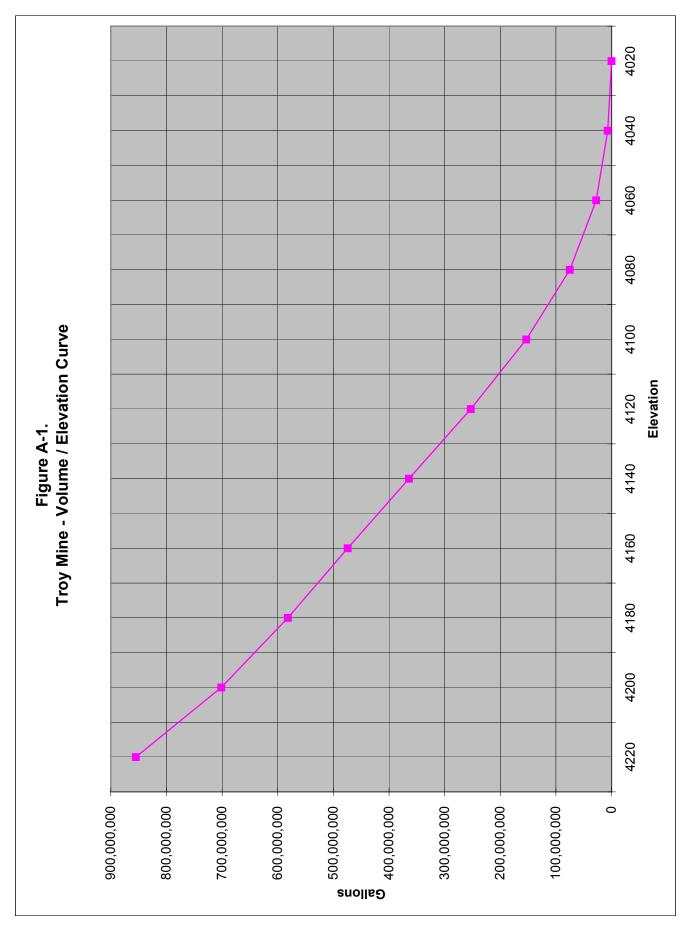
Water level rise in the mine was recorded by measuring the elevation of the mine pool relative to internal mine survey points. The mine pool rate of rise varied from about a tenth of a foot per day during low flow season to as much as 0.72 feet per day during July following snowmelt infiltration. Table A-1 summarizes the water level rise data for 2003. Figure A-1 shows the calculated mine capacity curve.

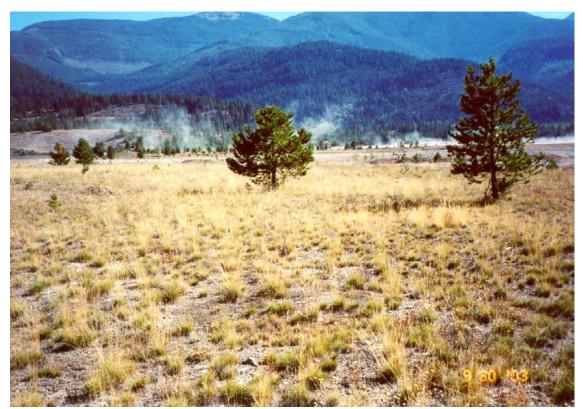
TEST PLOT C SHOWING LARGER TRANSPLANTED TREES

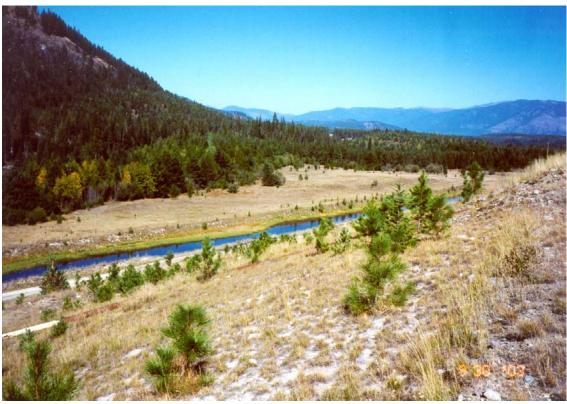
TREE ESTABLISHMENT ON TAILINGS EMBANKMENT – SEEPAGE COLLECTION POND BELOW EMBANKMENT TOE

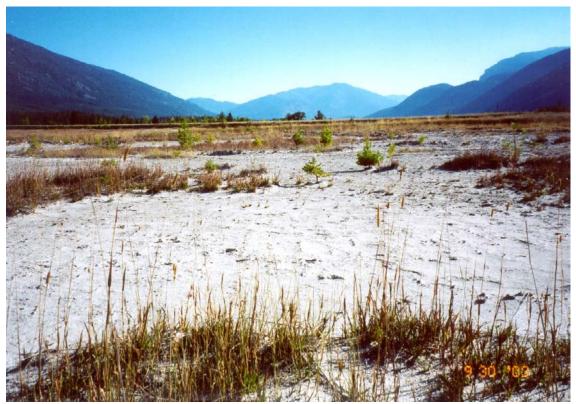
UNSOILED TAILINGS ON CELL 2

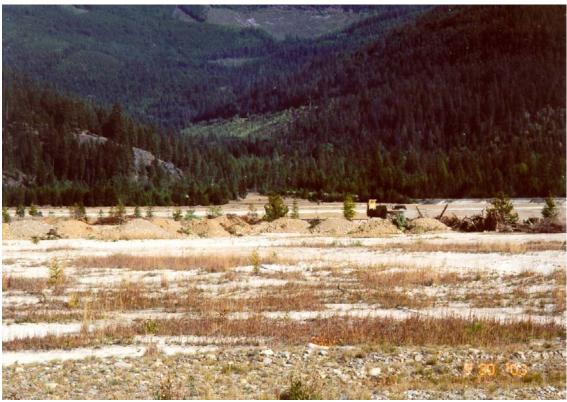
END-DUMPING ALLUVIAL MATERIAL ON CELL 2 – FOREGROUND SHOWS BOUNDARY BETWEEN REVEGETATED ALLUVIUM AND TAILINGS

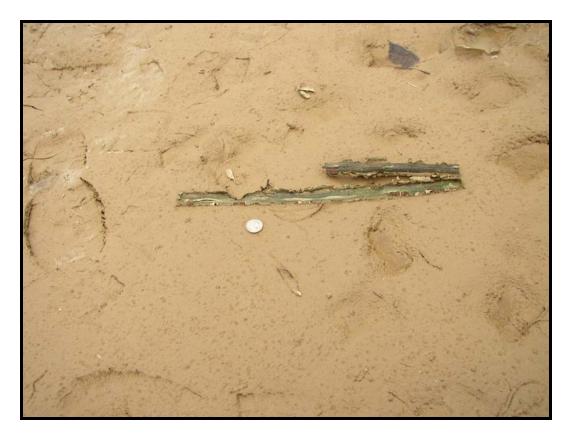
**Photograph No. 2:** Decant pond surface soil showing staining beneath stick. Quarter for scale.

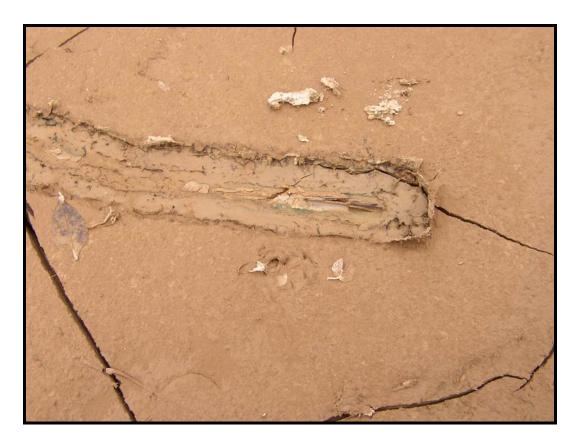
**Photograph No. 3:** Close-up beneath stick.

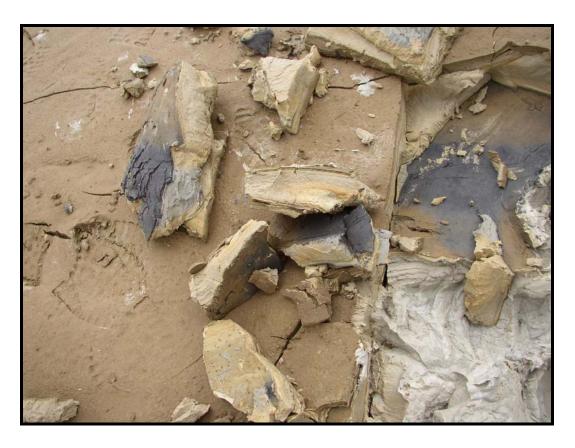
**Photograph No. 4:** Layering in soils and black staining associated with decaying organic matter.

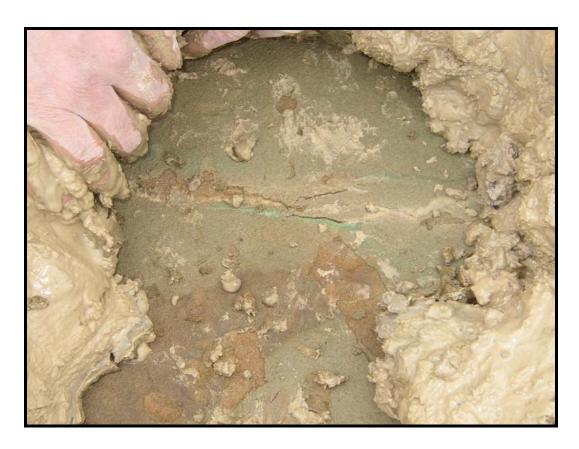
**Photograph No. 5:** Green and brown layering. Note bright green copper mineralization along fracture in center of photo.

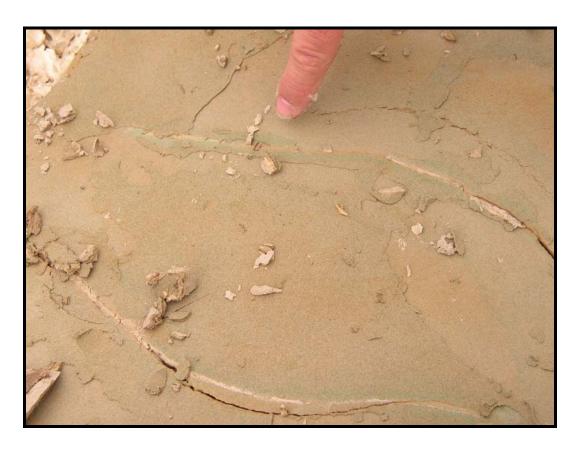
**Photograph No. 6:** Green copper mineralization in soils.

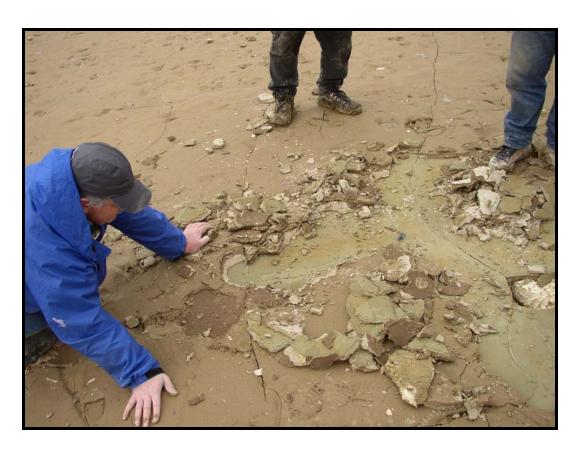
**Photograph No. 7:** Example of green and brown mineralization due to formation of secondary copper minerals.

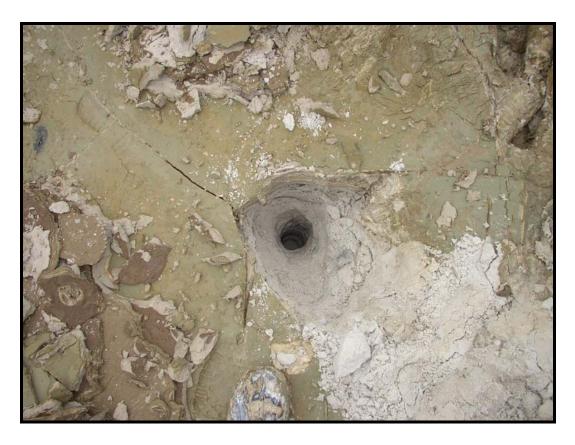
**Photograph No. 8:** View of deep (approx. 4 feet) boring. Note that mineralization (staining) is weak below surficial layers.

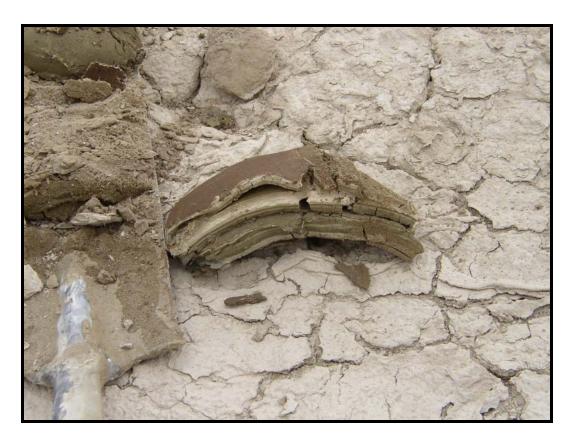
Photograph No. 3: Brown and green layering of copper mineralization in surface soil.

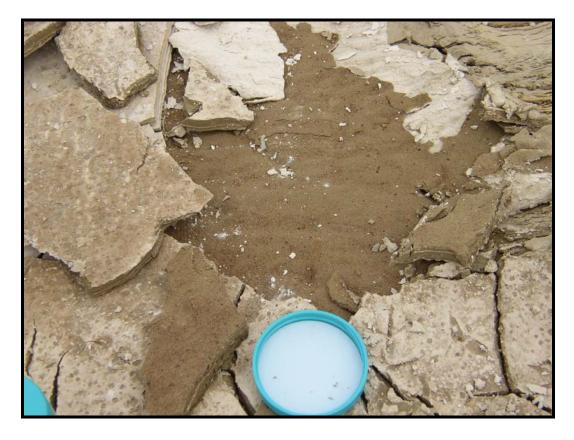
Photograph No. 4: Brown and green layering of copper mineralization in surface soil.

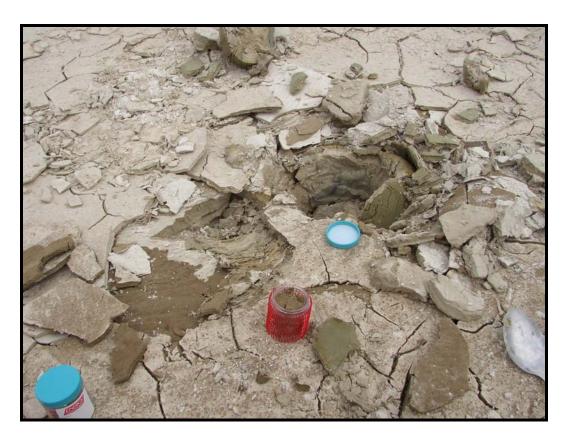
Photograph No. 5: Brown and green layering of copper mineralization in surface soil.

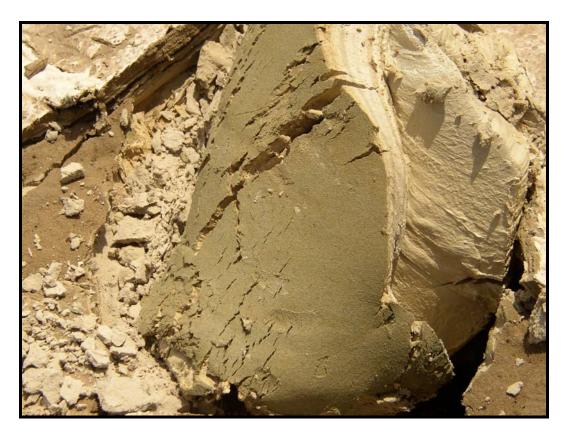
Photograph No. 6: Close-up of green copper-bearing layer.

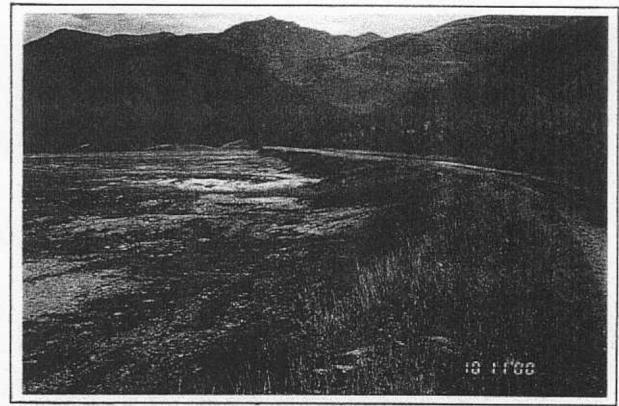
PHOTO 1: SOUTH SIDE OF TAILINGS POND LOOKING EAST. UPSTREAM SLOPE, CREST, AND OPERATING SPRINKLER SYSTEM ARE SHOWN.

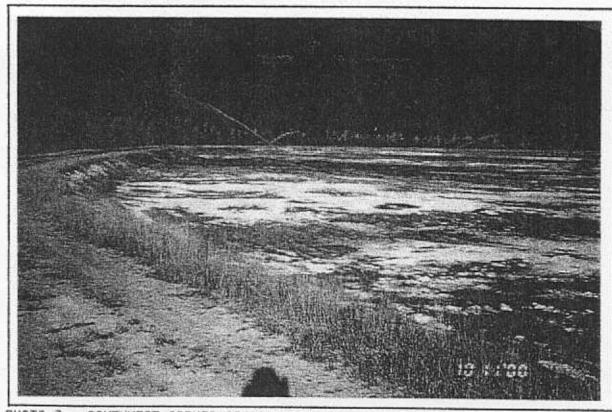
PHOTO 2: SOUTHWEST CORNER OF TAILINGS POND LOOKING NORTHWEST. THE CREST, UPSTREAM SLOPE OF THE EMBANKMENT AND OPERATING SPRINKLER SYSTEM ARE SHOWN.

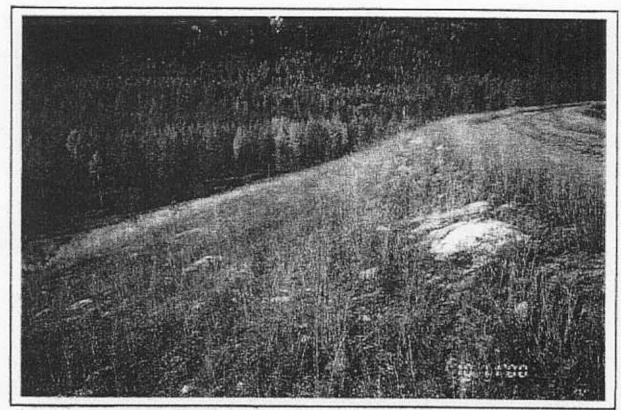
PHOTO 3: SOUTHWEST CORNER OF TAILINGS EMBANKMENT LOOKING WEST. THE CREST AND THE DOWNSTREAM SLOPE OF THE EMBANKMENT ARE SHOWN.

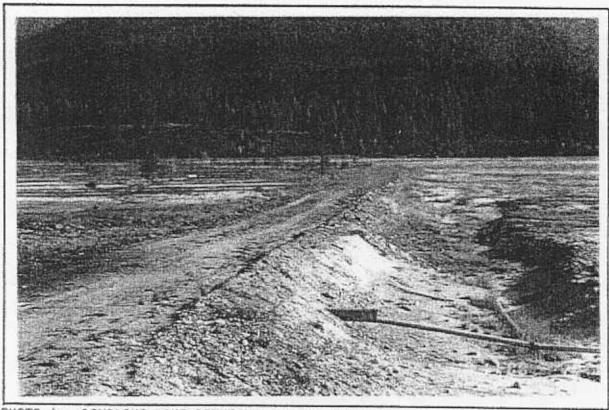
PHOTO 4: DIVIDING DIKE BETWEEN TAILINGS POND CELLS 1 AND 2. A PLANTING AREA ON CELL 2 AND THE DIVIDING EMBANKMENT ARE SHOWN.

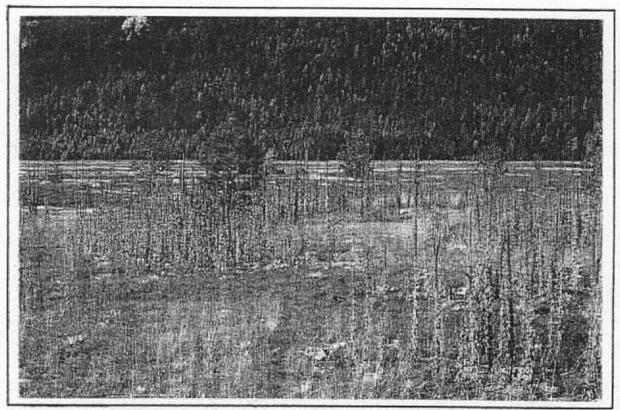
PHOTO 5: PHOTO TAKEN FROM EASTERN SIDE OF DIKE DIVIDING CELLS 1 & 2, SHOWS LARGE WEEDS AND TREES FROM CURRENT PLANTING OPERATION.

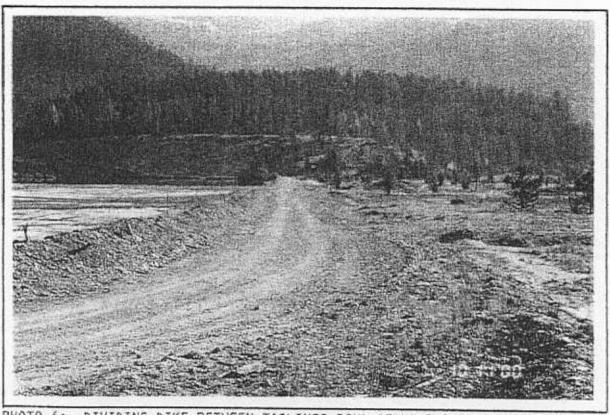
PHOTO 6: DIVIDING DIKE BETWEEN TAILINGS POND CELLS 2 & 3. SHOWS TREES PLANTED IN CELL 2 AND MINE WATER PONDED IN CELL 3.

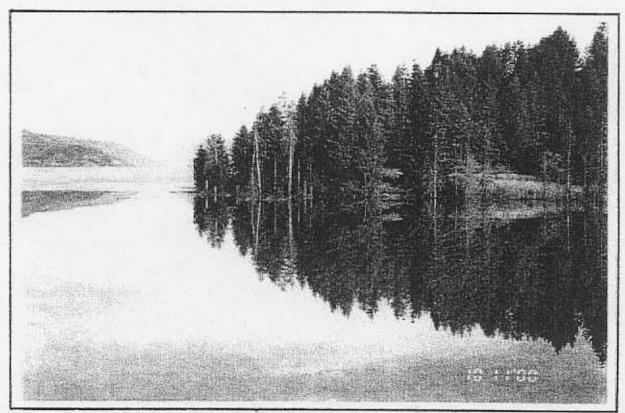
PHOTO 7: FROM ROADWAY NEAR DECANT WATER POND LOOKING NORTH. THE PONDED MINE WATER AND THE TAILINGS BEACH AREA IN TAILINGS POND CELL 3 ARE SHOWN.

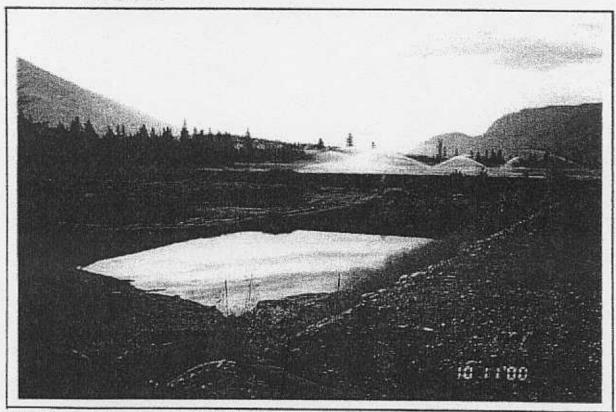
PHOTO 8: EAST END OF TAILINGS POND LOOKING SOUTH. THE UNUSED DECANT WATER RETURN POND AND SPRINKLERS OPERATING IN CELL 2 ARE SHOWN.

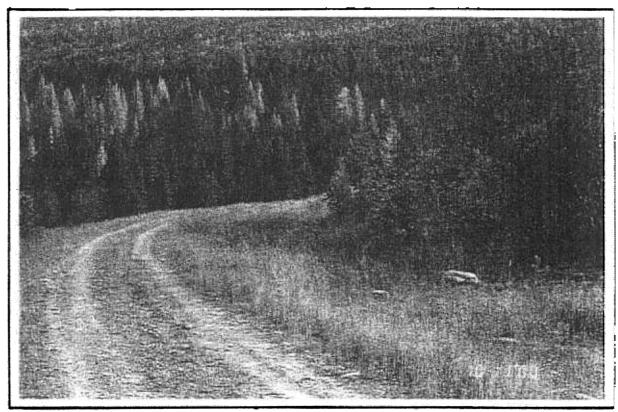
PHOTO 9: LOWER ACCESS ROAD LOOKING NORTHEAST. THE ACCESS ROAD AND TREES PLANTED SEVERAL YEARS AGO ON THE DOWNSTREAM SLOPE OF THE TAILINGS POND EMBANKMENT ARE SHOWN.

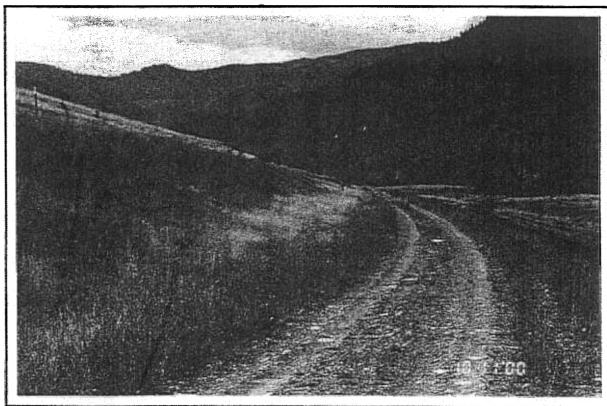
PHOTO 10: LOWER ACCESS ROAD LOOKING SOUTH. A PIEROMETER ON THE DOWNSTREAM SLOPE OF THE TAILINGS POND EMBANKMENT, A TOE POND AND A TOPSOIL DISPOSAL AREA ARE SHOWN.

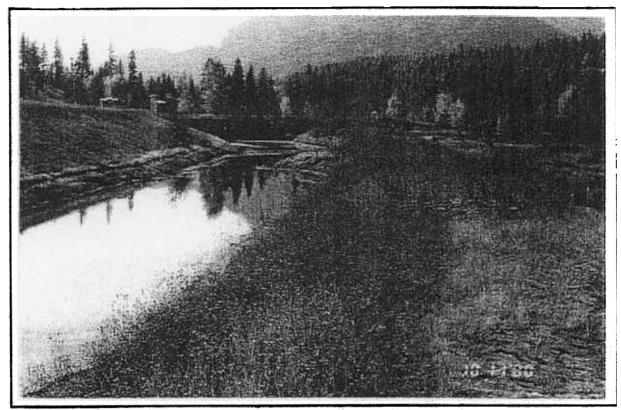
PHOTO 11: FROM WEST EMBANKMENT OF THE TOE POND DIKE LOOKING SOUTH. THE LOWER ACCESS ROAD, THE TOE OF THE ORIGINAL STARTER DAM, THE TOE POND, AND THE WEST EMBANKMENT OF THE TOE POND ARE SHOWN.

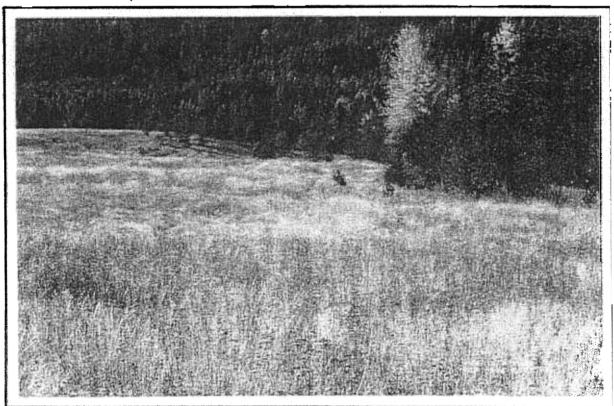
PHOTO 12: FROM THE WEST EMBANKMENT OF THE TOE POND DIKE LOOKING WEST. THE TOPSOIL DISPOSAL AREA AND THE LOCATION WHERE THE NATURAL SLOPE STEEPENS EAST OF LAKE CREEK ARE SHOWN.

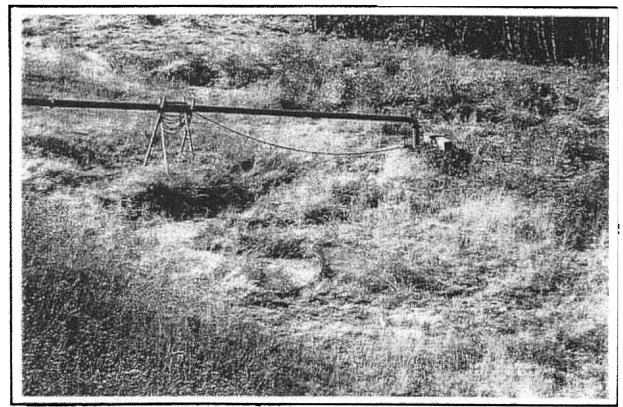
PHOTO 13: SUMP AND PUMP DOWNGRADE OF THE TOE PONDS WHICH WERE INSTALLED IN 1991 TO COLLECT SEEPAGE ARE SHOWN.

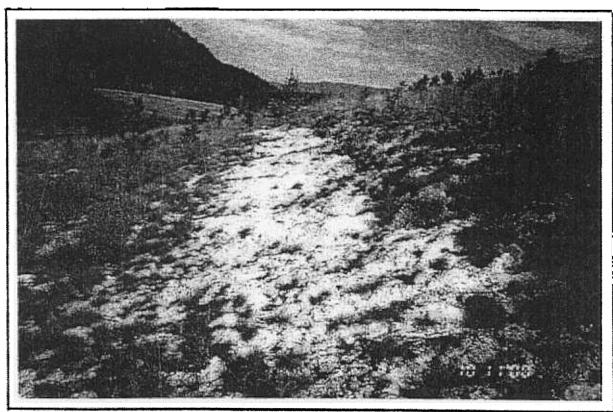
PHOTO 14: FROM A POINT ON THE DOWNSTREAM SLOPE OF THE TAILINGS EMBANKMENT LOOKING NORTH. THE TOPSOIL IN THIS AREA WAS NOT THICK ENOUGH TO COVER THE TAILINGS AND SUPPORT VEGETATION.
